Observational Study of the I₂ Air Purge Flush Method for Biofouling Control on UV Lamp Sleeves

Michael Radicone

I₂ Air Fluid Innovation, Inc., Oceanside, NY, USA, DSMI, Barrie, Ontario, Canada

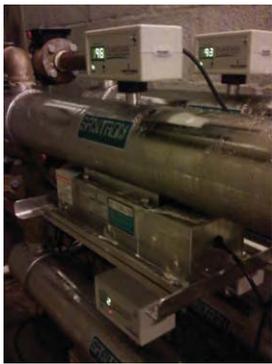
Three of the four purifiers were used for the study; upper front UF, upper back UB and lower front LF. Lower back LB was not used due to a malfunctioning meter.
