# Bidding, Testing, and Start-Up of a Reuse UV Disinfection System in Florida

**Josefin M. Edeback, E.I. and Melanie A. Mann, P.E.**

Hazen and Sawyer, P.C.  
10002 Princess Palm Avenue, Suite 200  
Tampa, Florida 33619

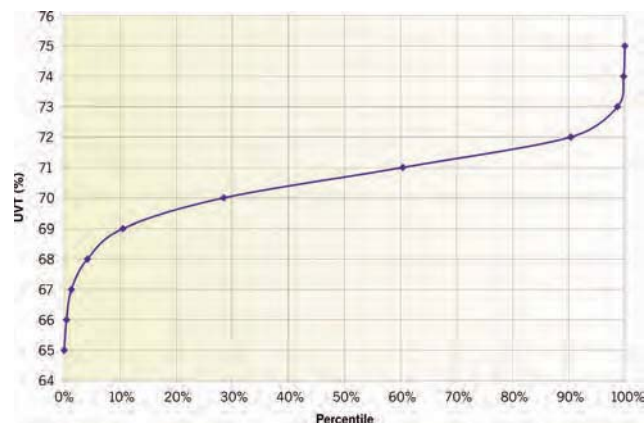
**Figure 1:** UV Transmittance Data

AWTP staff performed the required six months of UVT monitoring from May 2005 through November 2005. The 10<sup>th</sup>-percentile UVT value during this period was 68 percent. **Figure 1** presents a percentile plot of the UV transmittance data. To maintain a conservative design approach, a design UVT of 65 percent was used for the UV disinfection facilities at the Falkenburg AWTP.

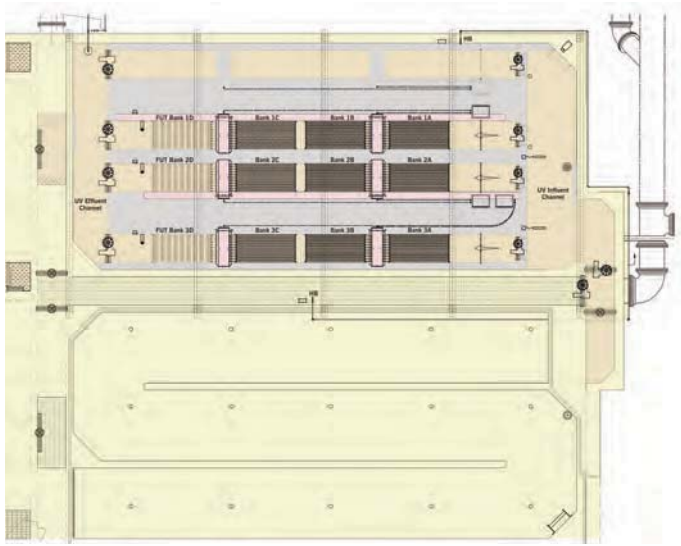
**Figure 2:** Horizontal Lamp Layout Configuration

Contract drawings included two alternative layouts for the UV facility. The horizontal lamp configuration depicted in **Figure 2** was applicable to the Trojan and ITT-Wedeco systems, and the vertical lamp configuration depicted in **Figure 3** was applicable to the Ozonia system. All systems were capable of providing a validated UV dose of 100 mJ/cm<sup>2</sup> at the maximum day flow of 16.7 mgd, with one channel out of service or one bank of lamps per channel out of service for redundancy.

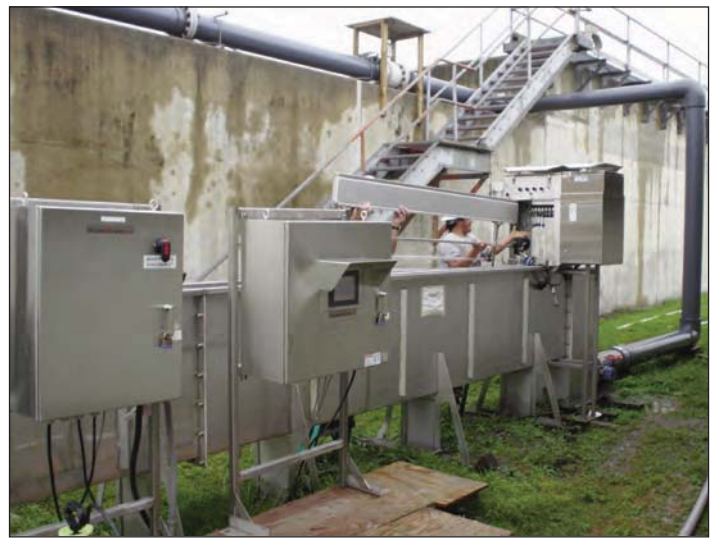
**Figure 4:** Photograph of On-site Fouling Factor Pilot Unit

Bid documentation for the Falkenburg AWTP included submitting the lamp fouling factor used by the manufacturer at the time of the bid and the number of UV lamps required based on that fouling factor. The County required the UV manufacturer to provide a pilot unit for a six-month test to determine a site-specific fouling factor. The fouling test was required because two of the three named UV vendors were using the unproven 0.80 fouling factor in their designs. The Trojan scope was based on a fouling factor of 0.95. The UV manufacturer was required to provide a pilot unit with at least eight lamps with the same lamp model and lamp cleaning mechanism as proposed for the full scale UV facility. A feed pump was used to transfer effluent from the filter clearwell to the UV pilot unit at a flow rate that provided velocity through the UV lamps equal to the average velocity through UV lamps in full scale at the UV facility. **Figure 4** is a photograph of the pilot unit provided by Trojan.

Trojan provided a pilot unit with twelve lamps which were operated continuously at 100 percent power using the wiping frequency recommended for the full scale installation. Also provided by the UV manufacturer was a spectrophotometer fitted for measuring the UV transmittance of the sleeves. UV transmittance measurements were made at a wavelength of 254 nanometers. Twenty-five random measurements along the length and around the circumference of each sleeve were taken at 0 days, 30 days, 60 days, 90 days, 120 days and 180 days of operation. **Figure 5** is a photograph of the spectrophotometer used for measuring the sleeve transmittance.

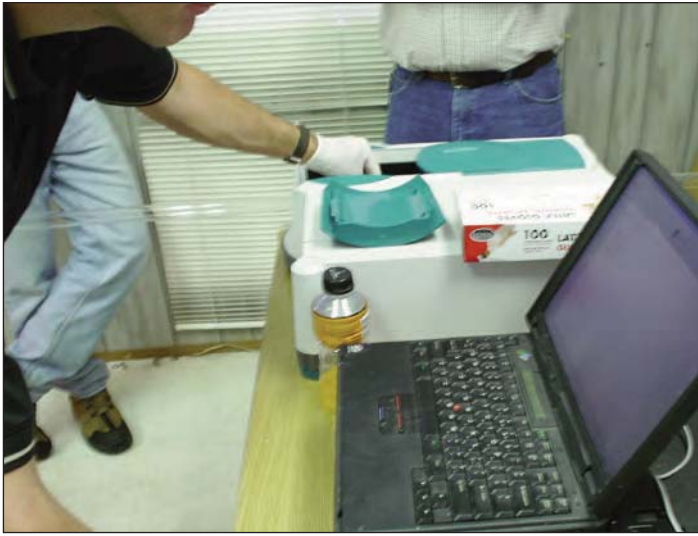
**Figure 5:** Photograph of Spectrophotometer

The spectrophotometer measured the UV transmittance through both walls of the round lamp sleeves, giving “double-wall” sleeve transmittance data. The single-wall sleeve transmittance was calculated by taking the square root of the double-wall sleeve transmittance value. The average of all transmittance measurements taken from one sleeve was considered the fouled UV transmittance for that

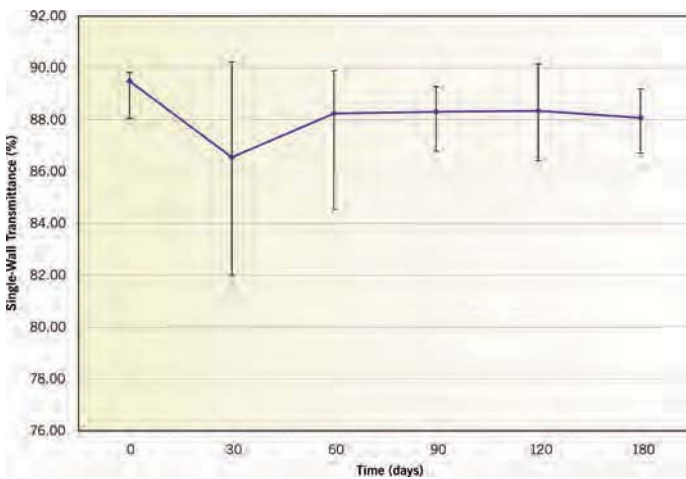
**Figure 6:** Single-Wall Sleeve UV Transmittance

sleeve for that operating time period. **Figure 6** depicts the trend of the average single-wall percent transmittance for all sleeves for each time period, and shows the range of transmittance values for each sleeve for each time period. Single-wall UVT ranged from 88% to 90% for new, clean sleeves.

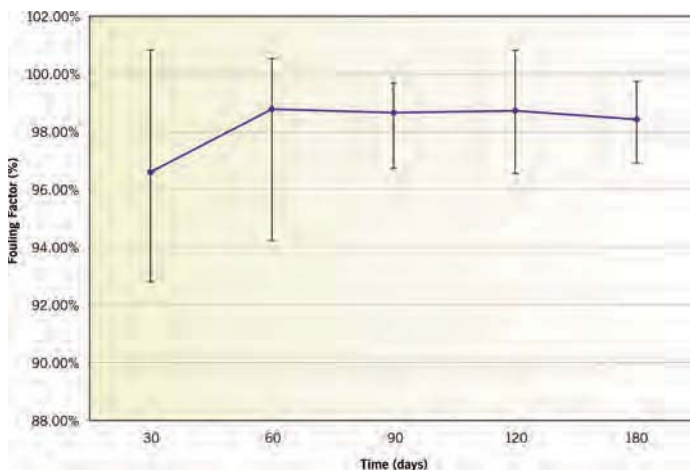
**Figure 7:** On-site Determination of Fouling Factor

The fouling factor was determined by dividing the transmittance of each fouled sleeve after each operating period by the original, clean transmittance for that sleeve at 0 days. The average fouling factor was determined for all of the sleeves for each time period. The lowest of the fouling factors from the 30, 60, and 90 day periods was then used to confirm the final sizing of the UV system in the main submittal for the UV equipment.

Trojan came to the site after 120 and 180 days of operation of the fouling factor pilot unit to repeat the above tests to fulfill the full 6-month testing requirement of the 2003 NWRI Guidelines (2) and that measurements be taken every two months. If the fouling factor was found to be lower than that reported in the first 90 days, the UV equipment submittal would be revised to reflect the lowest fouling factor measured. **Figure 7** presents the fouling factor calculated for each time period. The fouling factor was lowest when it was 0.965 after 30 days of operation, and it had increased to 0.984 after 180 days of testing.
